DTIC FILE COPY
MTL TR 88-48

CHEMICAL AND SURFACE CHARACTERIZATION OF TOW MISSILE CASES

SIN-SHONG LIN and WAI K. CHIN
MATERIALS SCIENCE BRANCH

December 1988

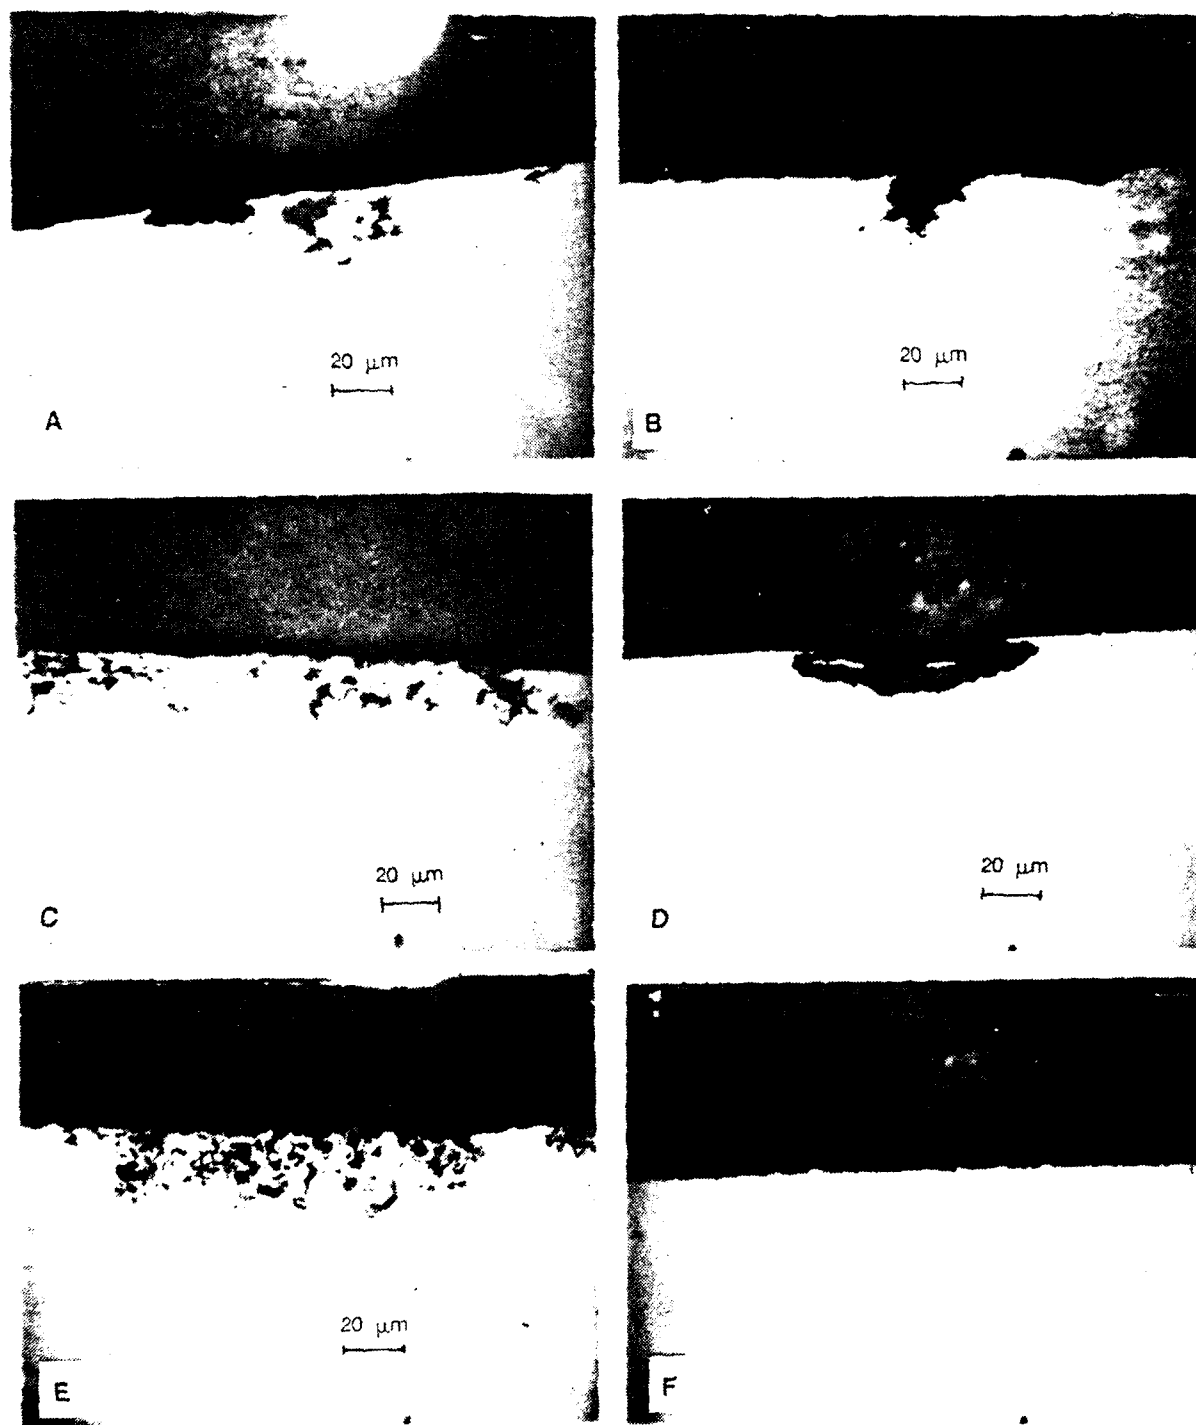
As shown in Figure 3, a few cracks are positively identified in the specimens from the two sources. In both instances, the microcracks are found to emanate from pits or crevices situated on the inner cylindrical wall. In general, these observed cracks extend approximately 20 micron depth from the surface, and have zigzag passages presumably through grain boundaries of the steel structure. The widths of the cracks are less than a few tenths of a micron. No fissure or crack is observed from the smooth inner surfaces. Evidently, the formation of these cracks is corrosion related.

For stress corrosion cracking, the crack initiation is usually derived from the environmentally corroded surfaces. Therefore, special attention was placed on identifying surface fissures and cracks from the cross-sectional microphotographs. In order for a crack to be detected, the cross-sectional cut must be made across the crack initiation areas. In Figure 3, some surface intrusions of corroded areas from the inner wall were observed, but only a few definite patterns of microcracks or fissures emanating from corroded surfaces were detected. These microcracks penetrated to a depth of 30 μm below the surface. The significance of this finding implied that there might be many larger corrosion

cracks extending to a few hundreds of microns depth below the surface. The existence of the microcracks clearly demonstrates that stress corrosion cracking is possible.

Figure 3. Cross-section micrographs of fracture pieces: (a) #O-5a (b) #O-7e (c) #O-13e (d) #Y-24e (e) #Y-41f (f) #B-2e. Except for (f), many microcracks and fissures are detected. The cracks initiate from corrosion pits or crevices and emanate into 20 micron depth.

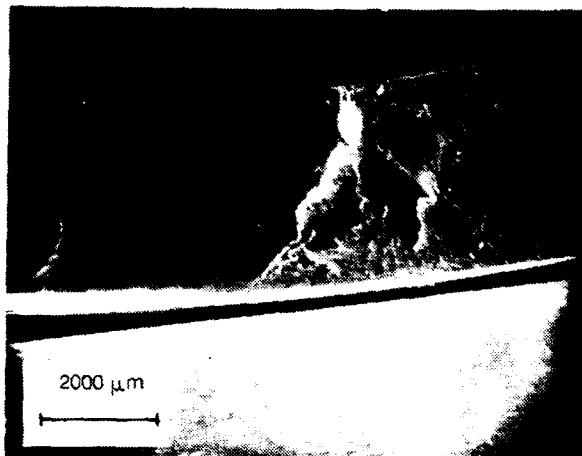
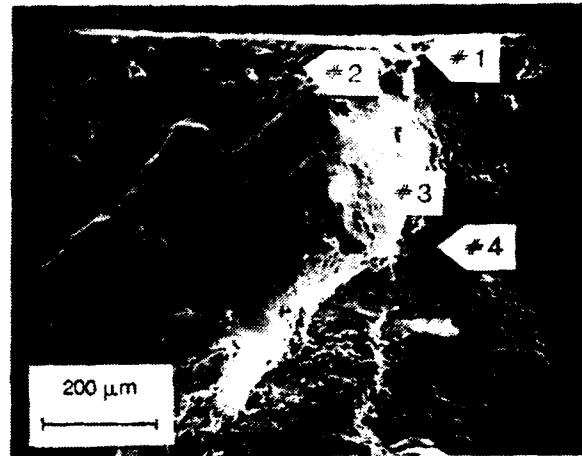
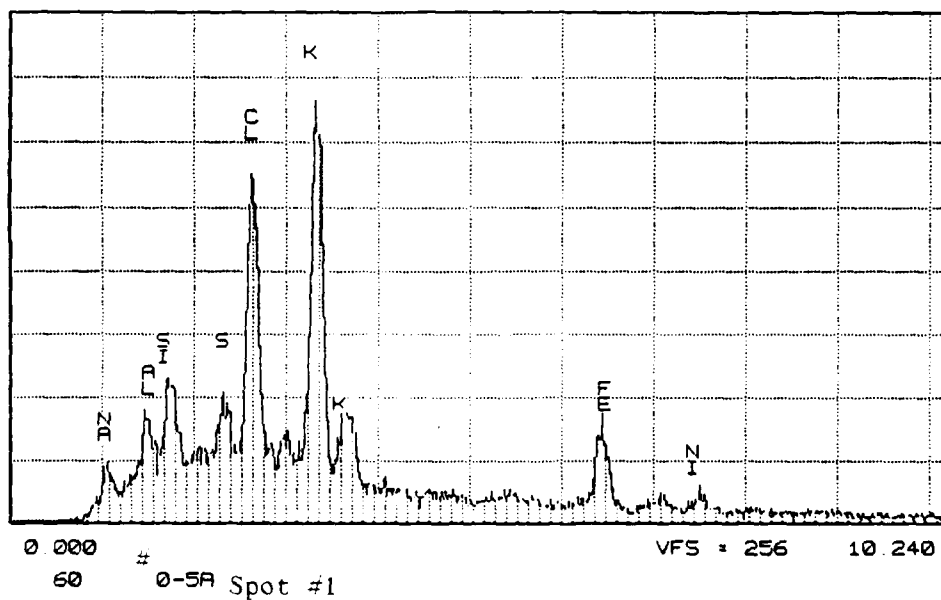
Figure 7. SEM of fracture surface #O-5a from Oahu failure.

#O-5a: The surface of this sample has been weathered and oxidized to a considerable extent. In the SEM photos (Figure 7), a protruded crack surface is shown. This cracked surface is highly oxidized and appears as brown coloration (from OM color photo, Figure 6) in contrast to bright metallic luster. Many small aggregations shown on the SEM photo are oxidation products. Subsequent EDXA analyses of the four spots reveal that there are high concentrations of K, Na, and Cl near the surfaces adjacent to the inner wall (#3, #2, and #1), especially at the edge of the boulder (spot #1, EDXA spectrum is shown). In contrast to the flat smooth portion of the fracture surface (#4) where no salt element is detected, these spots contain excessive amounts of Cl.

(a) Overview of fracture surface

(b) Enlarged fracture surface at a large crack. The spot compositions by EDXA are tabulated in Table 3

(c) Chemical composition of spot #1 by EDXA near inner wall

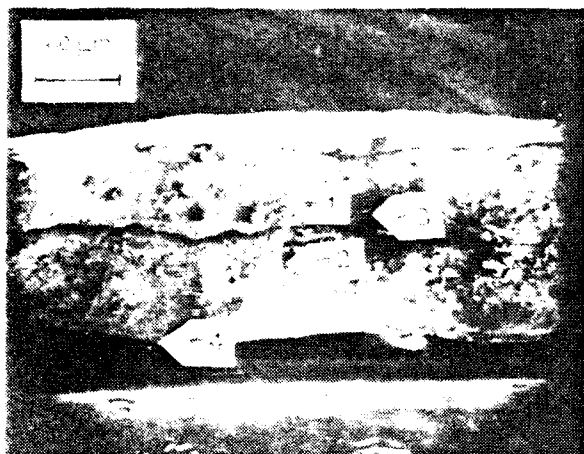
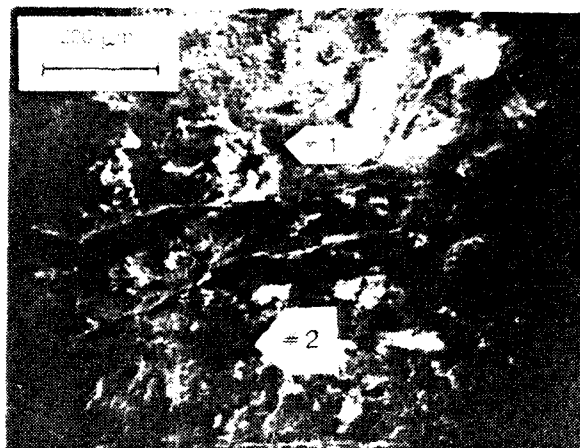
Figure 8. SEM of fracture surface #O-7e from Oahu failure.

#O-7e: The surface is found to have several strain fracture cracks running parallel to the cross section. The surface appearance is rusty brown with numerous fractures and cracked lines and edges. Some portions are rugged and others smooth, as shown in Figure 8. Composition analyses were made on four locations as indicated in the figure. The elemental constituents of these spots are very similar except for varying small concentrations of K and Cl.

(a) Strain cracks in fracture surface

(b) Detailed morphology of strain cracks. Spot numbers refer to EDXA chemical constituents

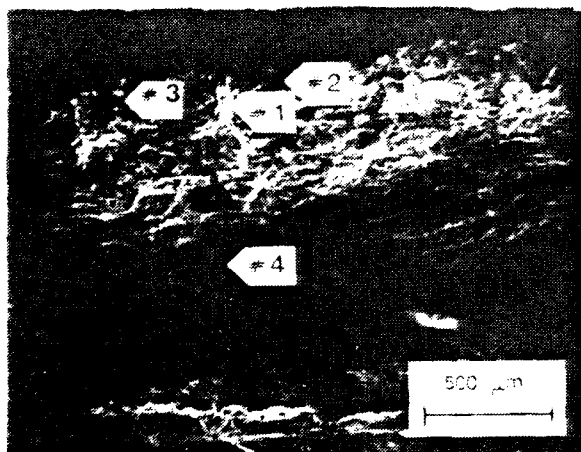
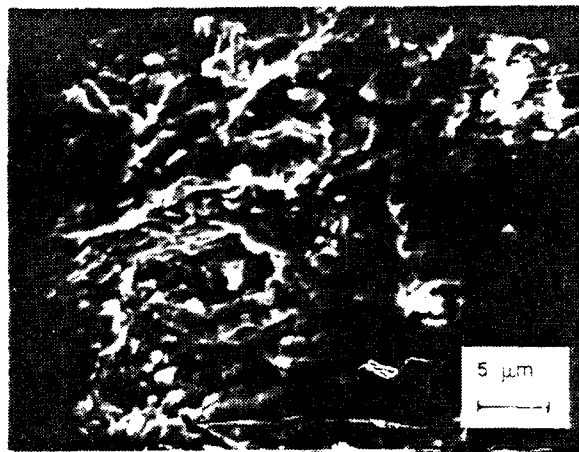
Figure 9. SEM of fracture surface #O-13e from Oahu failure.

#O-13e: This unique fracture surface (Figure 9) consists of many spots appearing as dark circular areas in the SEM photos (brown/black spots in OM photos, Figure 6). Presumably, these spots are preferentially oxidized portions of steel components. EDXA analyses indicate that they are mainly composed of maraging steel components with varying amounts of minor elements Al, Cr, and Ca. No Cl is detected.

(a) Fracture surface

(b) Magnified view of spot #4 on the top of crack edge

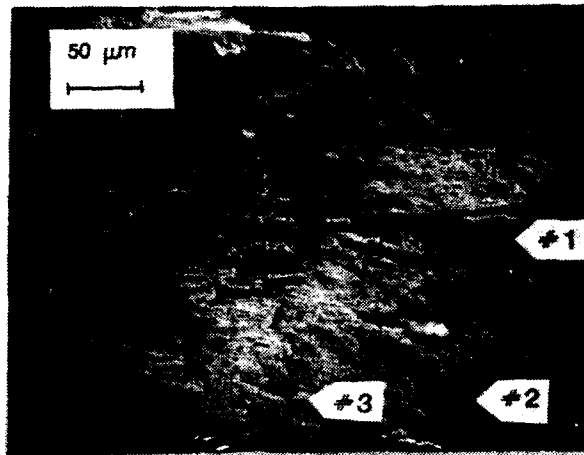
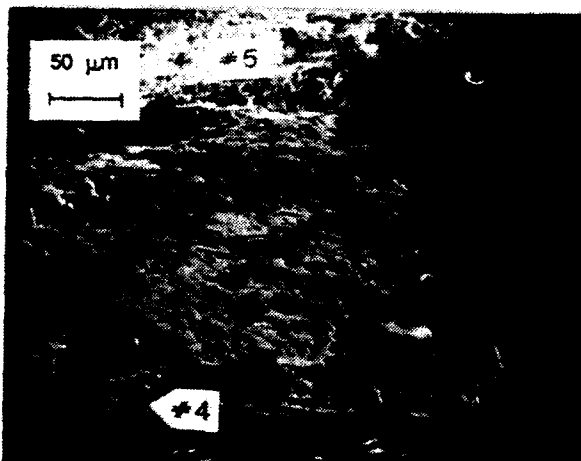
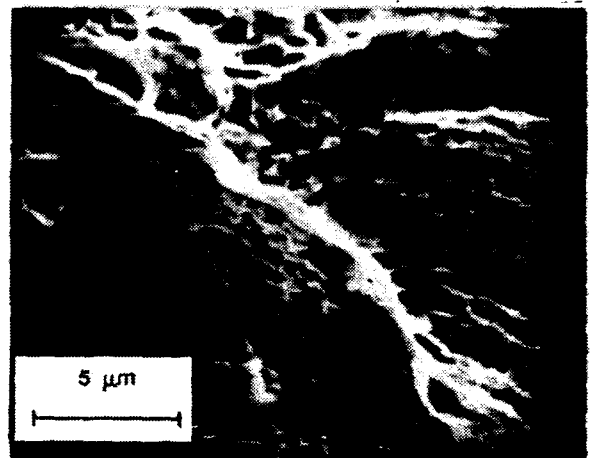
Figure 10. SEM of fracture surface #Y-24e from Yakima failure.

#Y-24e: The fracture area as shown in Figure 10 is oxidized to many localized brown patches throughout the surface. The EDXA analyses of the extruded crack ridge surface near the inner wall (#1 through #3), reveal that only #1 spot contains a small concentration of Cl. No Cl is detected on the adjacent two spots (#2 and #3). The enlarged area at the center (#4) shows that the surface is highly oxidized. The chemical compositions of all spots from EDXA are similar to the maraging steel except for relative abundances.

(a) Fracture surface of upper half adjacent to inner wall

(b) Fracture surface of lower half next to outside wall

(c) Enlarged area of spot #1 at the rim of a circle crater

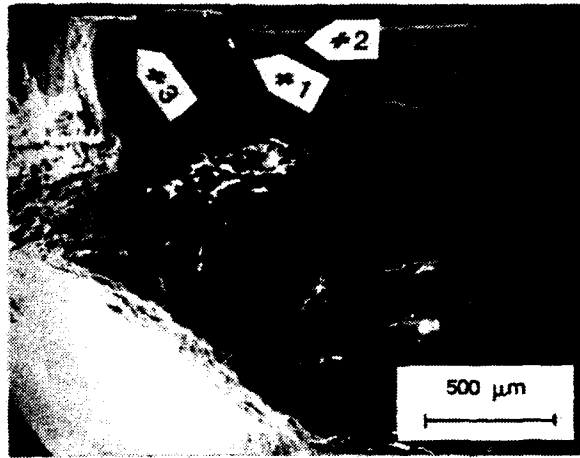
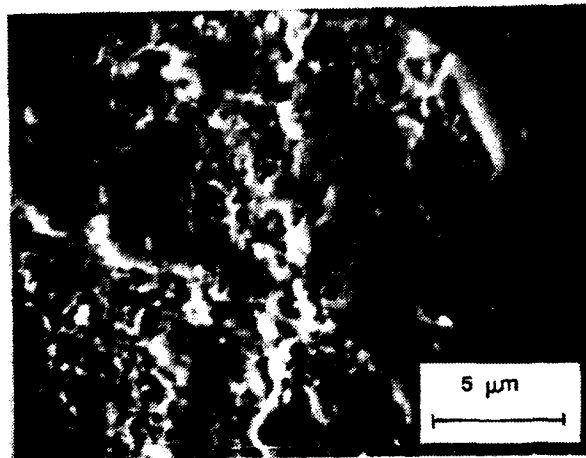
Figure 11. SEM of fracture surface #Y-41a from Yakima failure.

#Y-41a: The surface morphology (Figure 11) of this specimen is very similar to that of #Y-24e. The spot (#1) on the cracked surface near the inner wall shows the presence of Si, K, Cl, and Al in addition to the elemental steel constituents, but the adjacent spots (#2 and #3) show only the components of the maraging steel. The occurrences and distribution of these exotic elements suggest they are derived from contamination.

(a) Cracked surface at a low glazing angle

(b) Enlarged view of spot #1 on the tip of crack

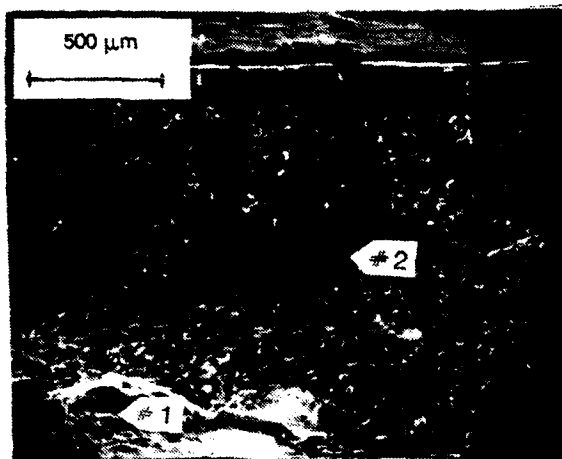
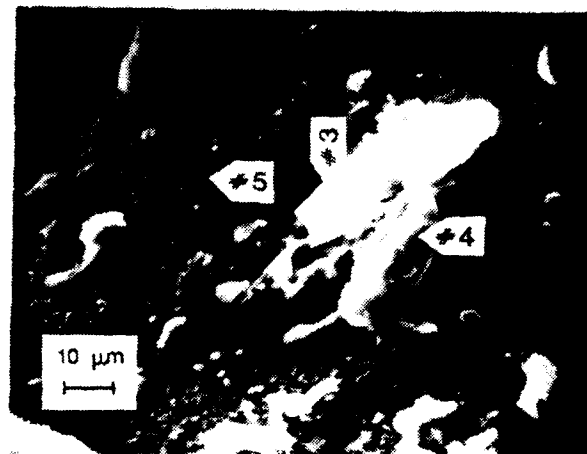
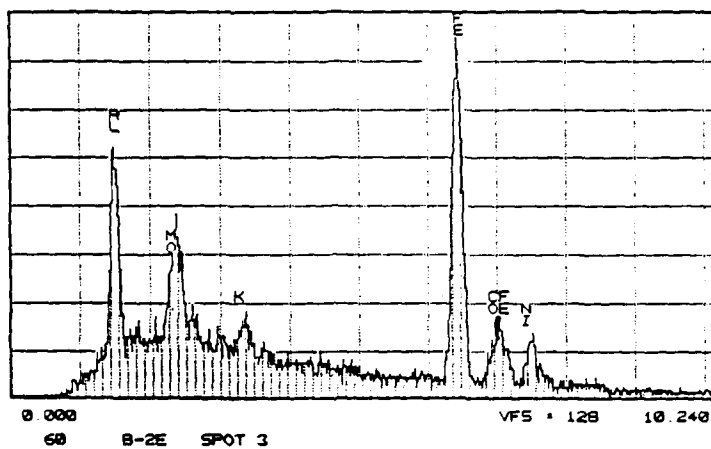
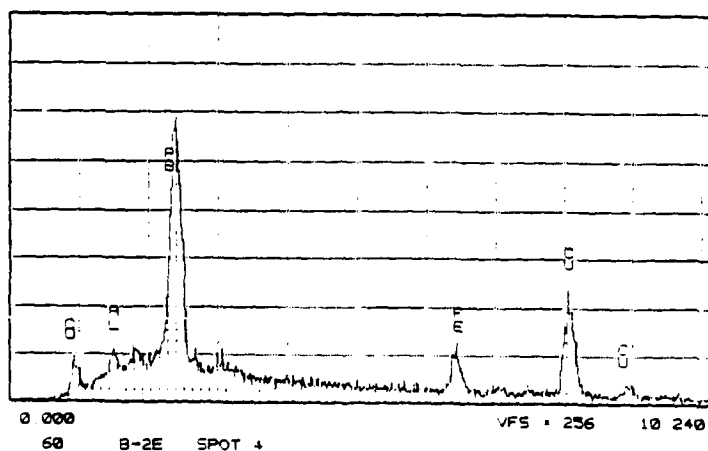
Figure 12. SEM of fracture surface #B-2e from blanket test (reference).

#B-2e: This surface is distinctly different from the two failure samples. Numerous small particles (about 20 μm or less) were found to fuse and to embed on the fractured surface (Figure 12). The particle with round corners and edges (#4) is found to contain large amounts of Cu and Pb, while those with sharp edges (#3) have high contents of Al and Mo as compared to the metal compositions of the maraging steel (#1 and #5). EDXA spectra of spots #3 and #4 are shown in the figure. No Cl is found throughout the surface.

(a) Fracture surface with numerous precipitates

(b) Magnified morphology of spot #2 containing imbedded foreign particles

(c) EDXA analysis of spot #3, square particle

(d) EDXA analysis of spot #4, round particle

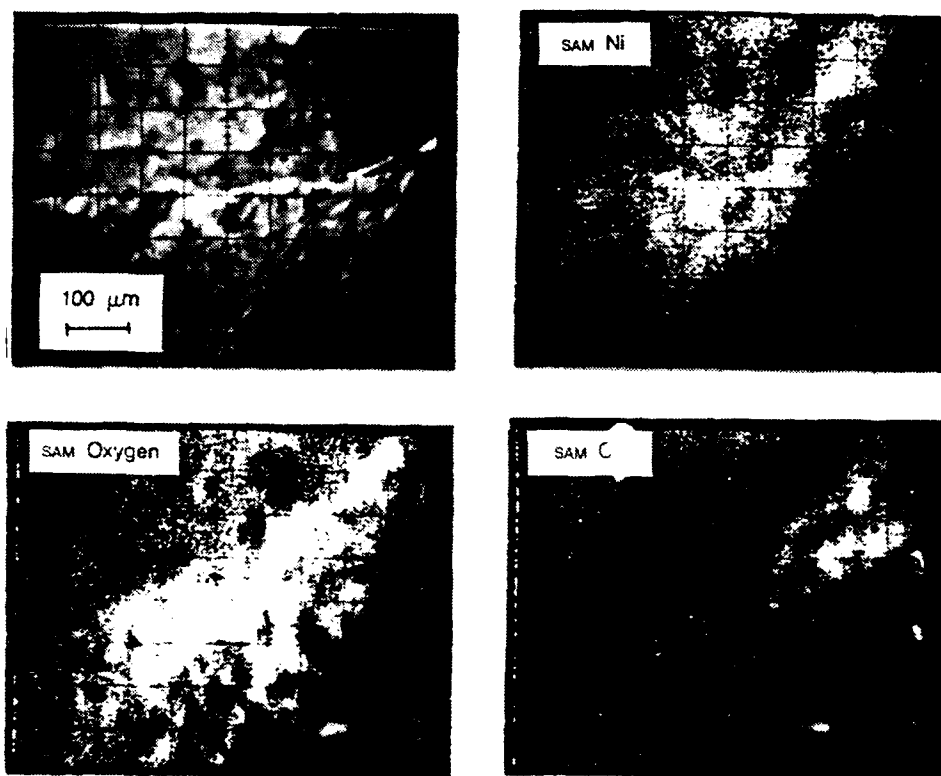
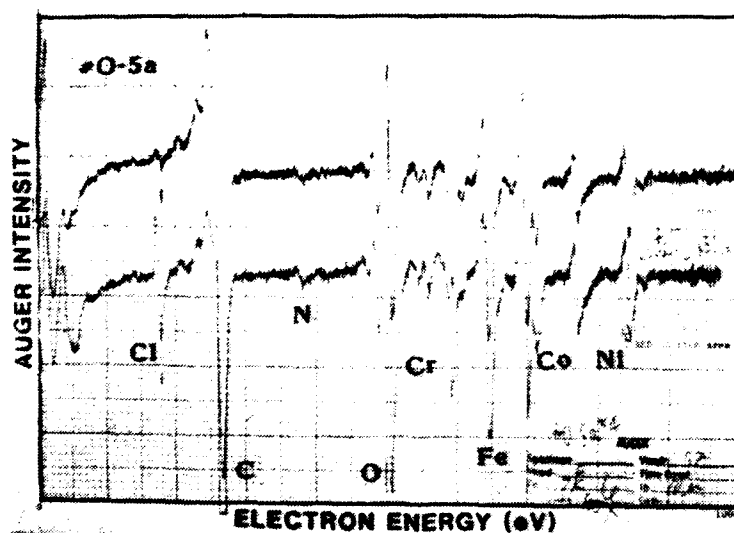
Figure 13. SAM images and AES spectra of fracture surface #O-5a.

#O-5a: In addition to the elemental constituents of maraging steel, a few foreign elements are observed on the fracture surfaces. They are Cl, O, and N. Oxygen is a component of oxidized metal layers and nitrogen probably derived from propellant remains on the surface. The distribution of Cl is rather unique. As shown in Figure 13, the high concentrations are observed near rims and edges of the cracked surface adjacent to the inner wall, and the two pits situated on the inner wall. No Cl is observed away from the inner wall. The presence of Cl is also confirmed by AES spot analysis. The element is one of the chemicals known to cause stress corrosion cracking.²

(a) SAM images: reference, nickel, oxygen and chlorine (Cl).
The Cl image is concentrated near the inner wall

(b) Two Auger spectra: one with Cl and another without Cl

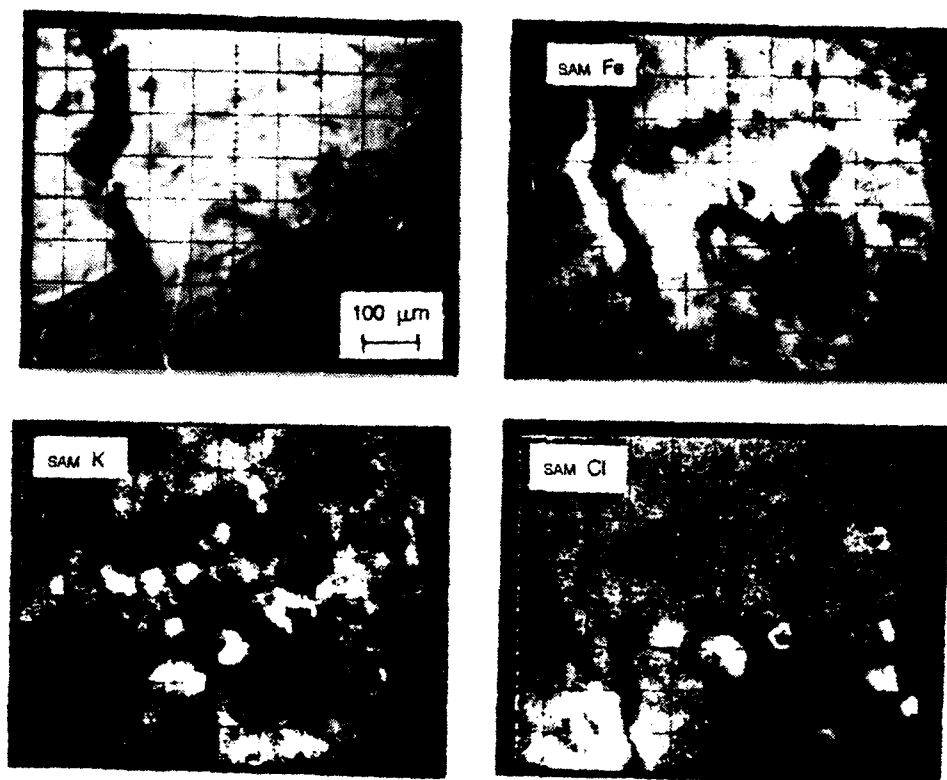
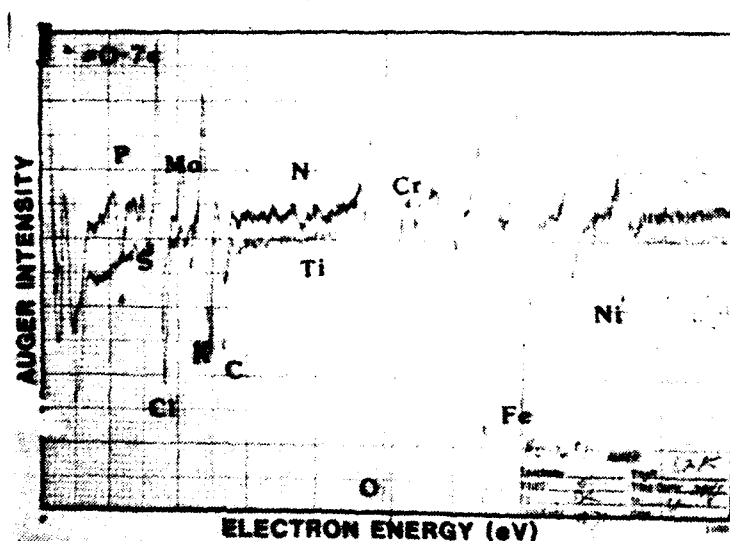
Figure 14. SAM images and AES spectra of fracture surface #O-70.

#O-7e: The SAM imaging is obtained on the region containing a strain crack. As expected, the surface is highly oxidized and contaminated. Several concentrated Cl sites are observed as illustrated in Figure 14. The SAM imaging and analyses also revealed a widespread concentration of K. These K and Cl sites are widely scattered and they could only be derived from the surface contamination by the missile propellant. Two AES spectra illustrate the magnitude of Cl on two different locations.

(a) SAM images: reference, iron, potassium (K) and chlorine.
The K and Cl are widely scattered

(b) Auger spectra with/without chemical element Cl. The X and Y locations of analyses are indicated

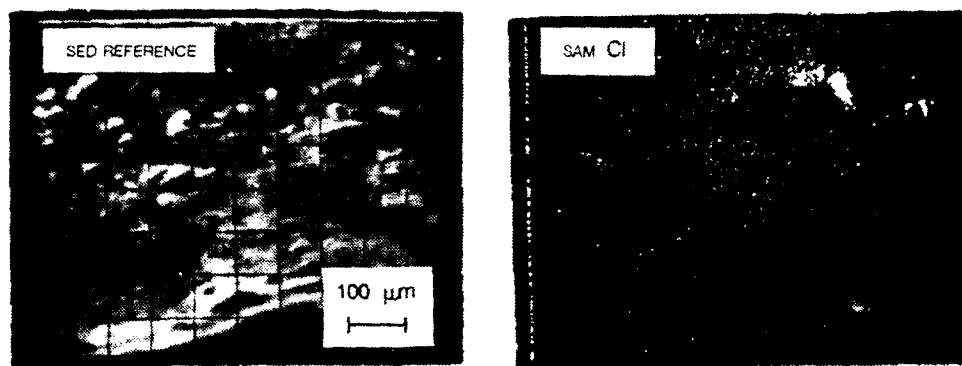
Figure 15. SAM images of fracture surface #O-13e reference and chlorine images. The Cl rich area is not near the inner wall, but is situated at a half wall thickness

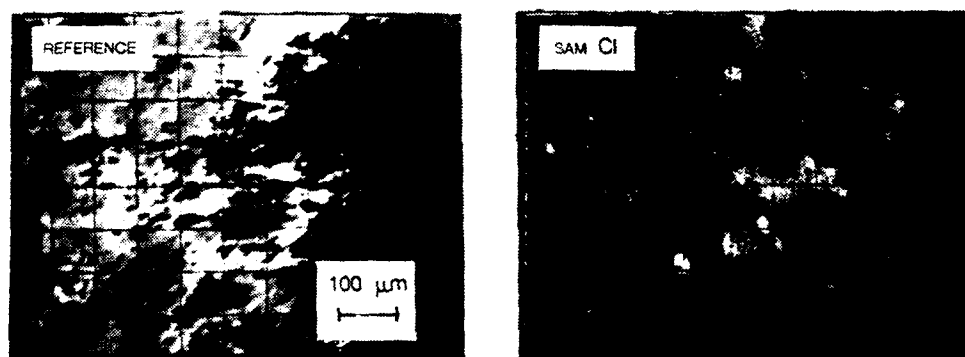
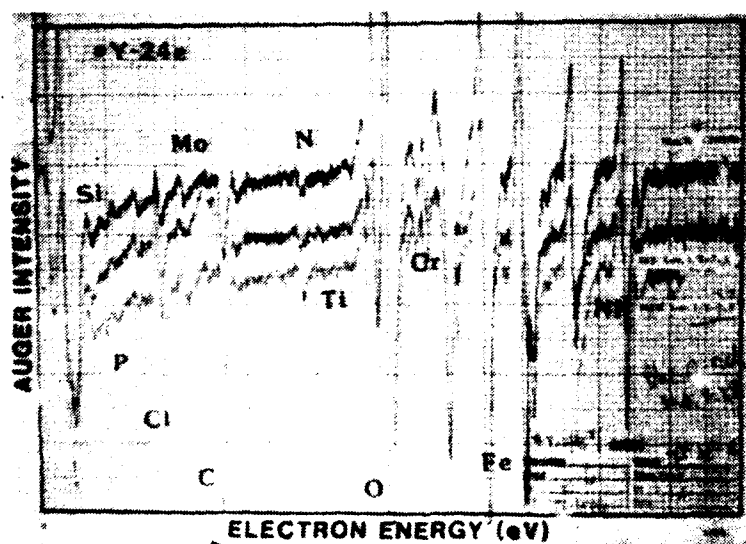
Figure 16. SAM images and AES spectra of fracture surface #Y-24e.

#Y-24e: This sample obtained from Yakima failure exhibits several Cl concentrations on the fracture surface. Most of the Cl is aggregated near the inner wall as shown in Figure 16. The AES spectra clearly confirm the presence of Cl.

(a) Reference image and SAM chlorine near inner wall

(b) Auger spectra taken at three locations: center, two Cl rich spots

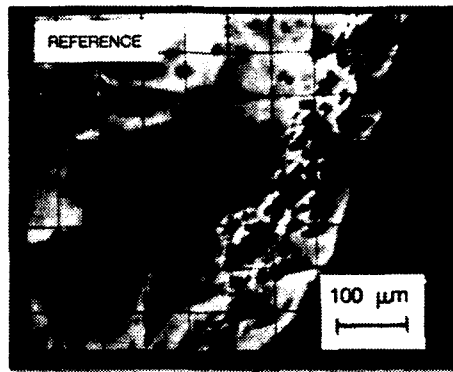
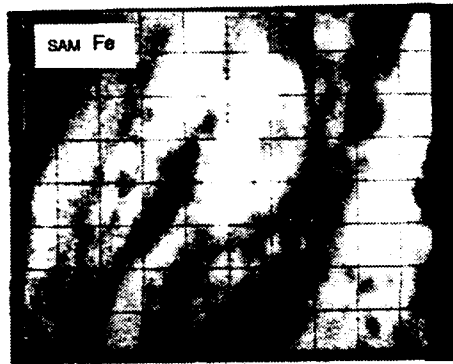
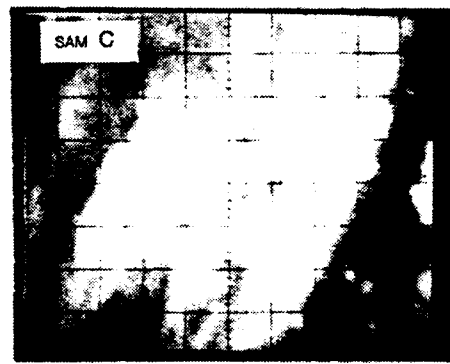
#Y-41a: No Cl is observed in the imaging area of this sample. The fracture surface (Figure 17) is mostly oxidized and contaminated with nitrogen/NO containing hydrocarbons. A large Ca signal is observed in one of AES spectra (not shown) obtained from this area.

Figure 17. SAM images of fracture surface #Y-41a: reference, iron, and carbon.

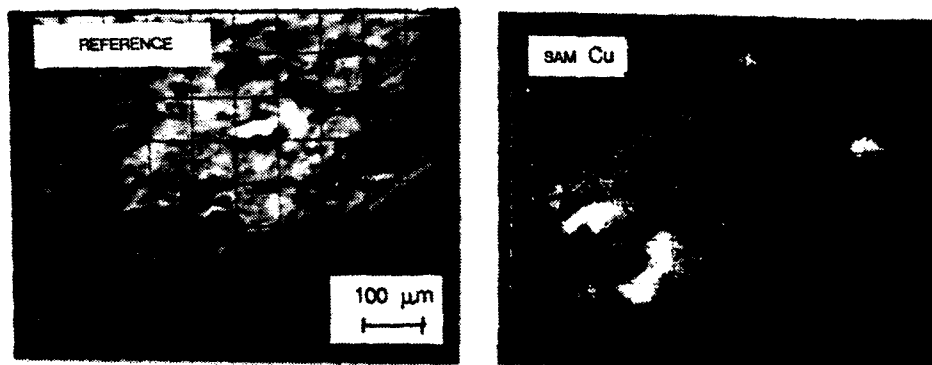
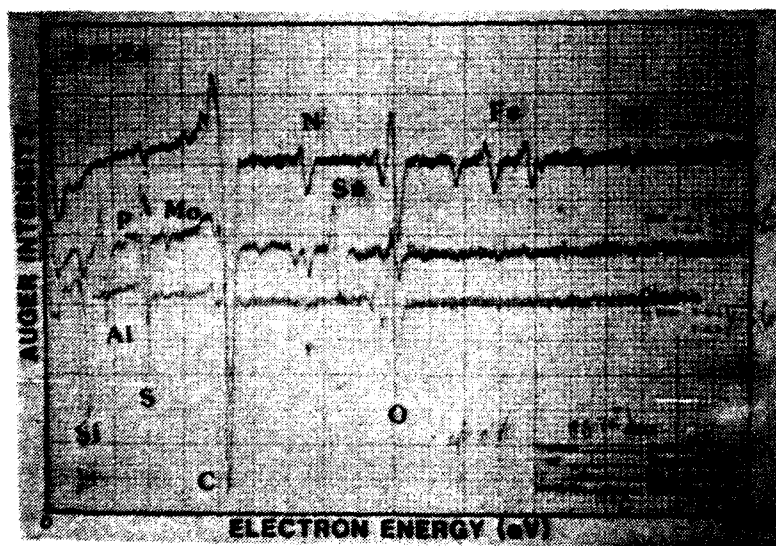
Figure 18. SAM images and AES spectra of fracture surface #B-2a.

#B-2a: This reference (blanket test) sample shows no Cl element on the fracture surfaces. Instead, many exotic elements such as Cu, Sn, S, Si, and Al are observed. Al and Si are present in excess of the steel components and Cu and Sn are found to scatter widely. Those metals are probably derived from aerosol particles during explosion. Sulfur always coexists with oxygen and is probably presented as sulfate or sulfite. Only Cu elemental distribution is shown in Figure 18 together with three AES spectra containing those foreign metals.

(a) Reference and copper SAM images

(b) Auger spectra at Cl rich region and at metal rich area
